DEPARTMENT OF NATURAL RESOURCES
DIVISION OF OIL, GAS AND MINING

RE: Site Inspection, Allroc Products, Allroc Pit A, M/035/018, Salt Lake and Davis Counties, Utah

Date of Inspection: January 30, 2003
Time of Inspection: 12:10 to 1:40 p.m.
Conditions: Mostly cloudy, 40's
Participants: Rick Morgan, Allroc; Doug Jensen and Paul Baker, DOGM

The primary purpose of the inspection was to use a global positioning system (GPS) unit to map and measure the area of the mine. The operator is hoping to be able to permit the site as a small mine, at least for now. The site has been sold to Lakeview Rock Products which should take over as operator in a few months.

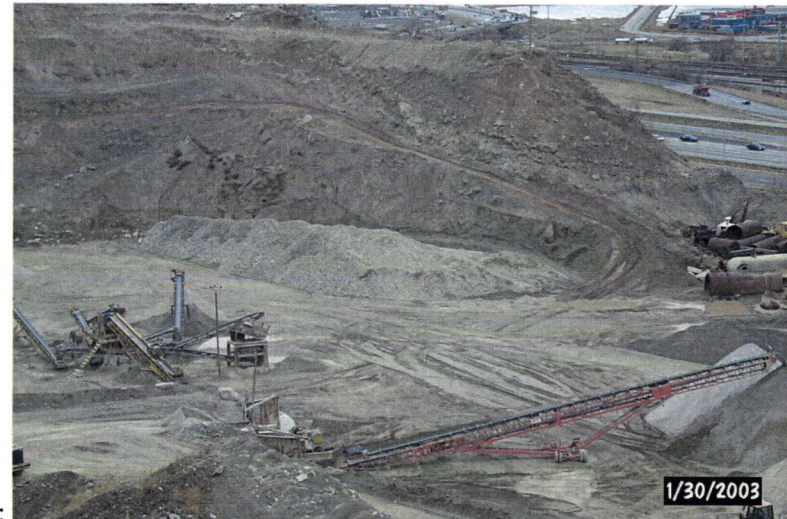
During the inspection, two front-end loaders were putting material through a crusher and screen. This material was then taken by conveyor to a stockpile (Photo 3). A dozer (Photo 4) was working a bench to push material down to the front-end loaders. The marked area was one bench above the area where the dozer was working.

Photo 3. Conveyor, stockpile, and some of the processing facilities.

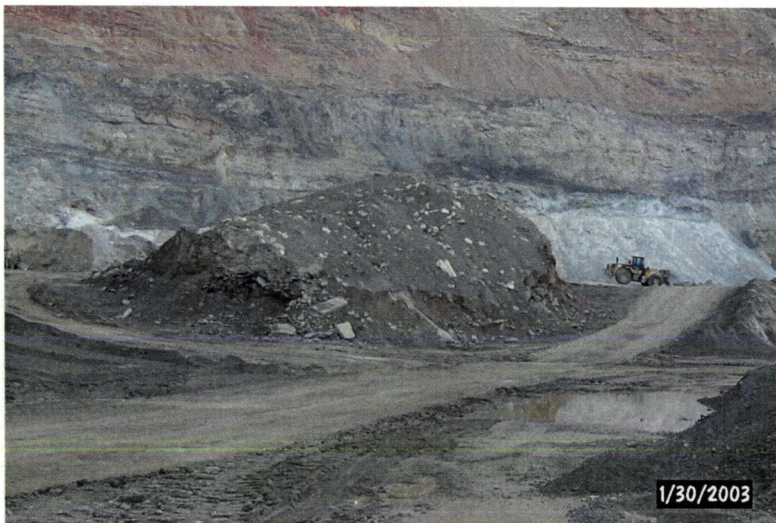
Photo 2. Pile of concrete within the disturbed area. This concrete is being recycled.

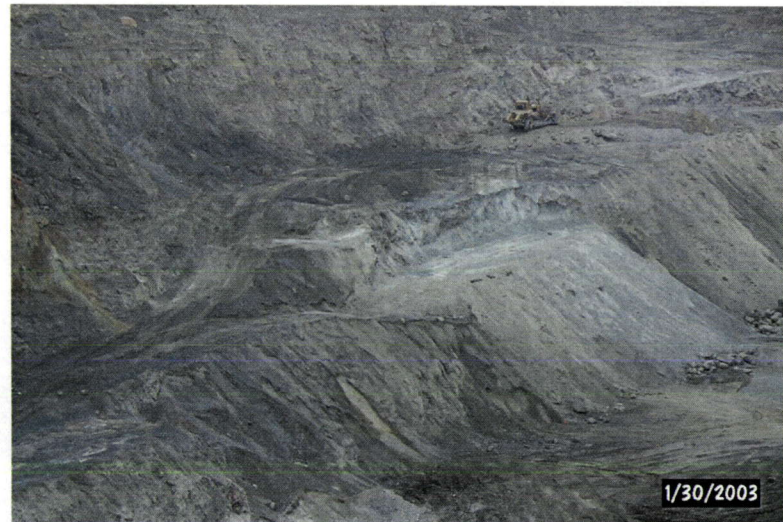
Photo 4. Dozer operating on the lower bench.
